# Control of variable frequency vibration in large span composite construction floor in a high rise building

## ABSTRACT

A new 31 storey commercial building was the subject of complaints regarding excessive floor vibration. There were some concerns regarding footfall induced floor vibration, but the majority of complaints came from the 19<sup>th</sup> floor, above the 18<sup>th</sup> floor plant room where a number of large, slow speed, vibration isolated, centrifugal fans were operated by variable speed drives (VSDs).

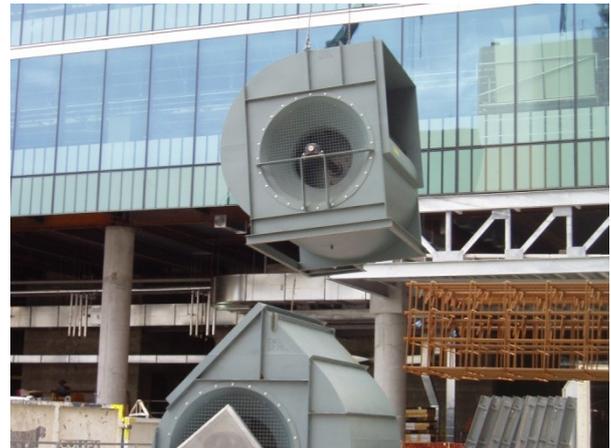
Figure 2. AHU 18 -1 SA fans being lifted into position during construction

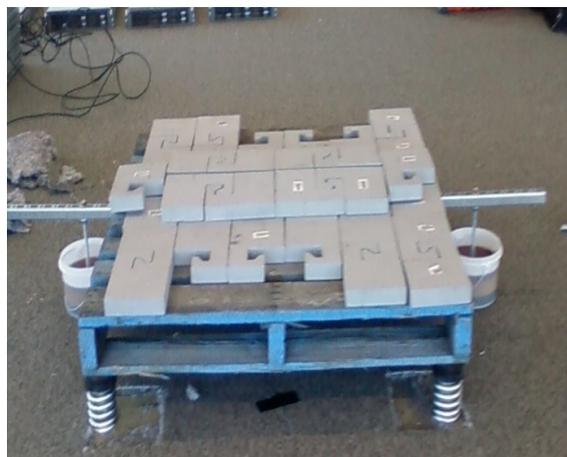
With vibration levels at 6Hz, considered excessive; even after many modifications, a tuned mass damper was trialled to determine the reduction possible at 6Hz. The design of the TMD is based upon theory given by Rao and the prototype is shown in Figure 6 with no damping and Figure 7 with damping. The estimated effective floor mass was 20,000 kg and using a 430 kg TMD mass this gave a mass ratio of 2.15 %.

Figure 7. Prototype TMD with viscous dampers

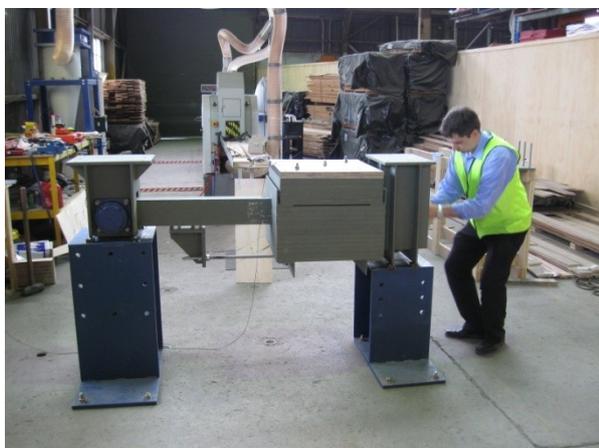
A variable frequency TMD was designed to address this problem. The TMD mass sits on an arm at the free end; the other end is held by a pivot joint. At the free end the TMD spring and damper are located. The entire unit is rigidly attached to the L-19 floor to provide efficient force transfer with minimal displacement. On-site tuning was required to match the exact floor frequency to the TMD resonant frequency. The TMD was designed to achieve a 20 year design life with regular maintenance and servicing. Variable tuning is obtained by moving the TMD mass back and forth along the arm using a worm drive. Details of the variable frequency TMD are given in Figures 11 and 12, and schematic is shown in Figure 13.

Figure 11. Side view of variable frequency TMD, during factory testing.

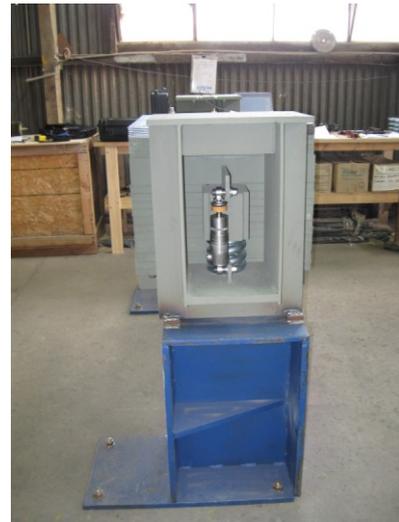
Figure 12. End view of variable frequency TMD showing dashpot and spring during commissioning.
