The Eighth Western Pacific Acoustics Conference

Melbourne, Australia, 7 - 9 April 2003

SOUND INSULATION OF TIMBER FRAMED STRUCTURES

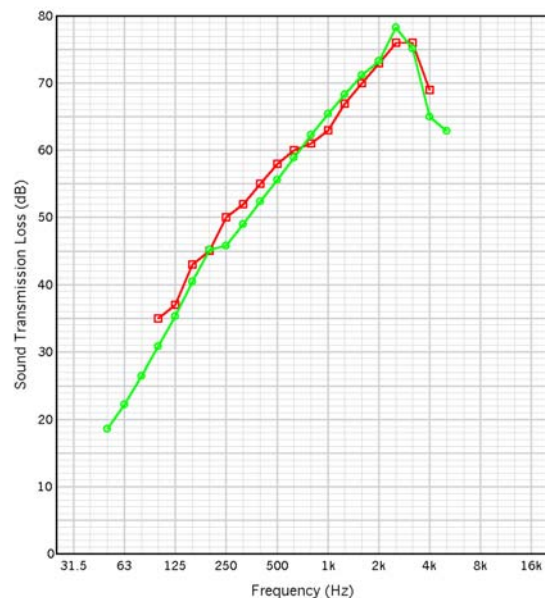
Fig 2 Double frame wall with 2x10mm gypsum board on each side

—□— measured
—●— predicted for ideal double wall

An illustration of the validity of these simple relationships is given in Fig 2 for a double stud construction lined on each side with 2 layers of 10 mm thick gypsum plasterboard, with a 100 mm fibreglass blanket in the cavity. For most engineering purposes this agreement can be taken as excellent.

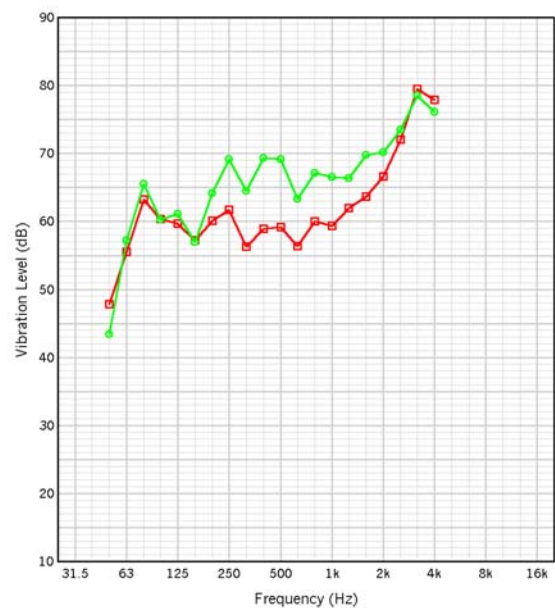
Fig. 4 Vibration measured on gypsum board on stud line for single stud wall

measured on screw
measured between screws

In Figure 3 it can be seen that the measured results exceed the results predicted for line connection above 400 Hz. The explanation for this is considered to lie in the behaviour of the connections between plasterboard and stud. In Figure 4 the relative velocity of the screw compared to a point on the plasterboard lying along the stud but halfway between screw fixings are shown. If there was a true line connection then the velocity should be same all along the line of the stud, but it can be seen that at frequencies above about 250 Hz the plasterboard between the screw fixings is moving much less, interestingly above 2,500 Hz the connection appears to move as a line connection again. Between 250 Hz and 2,500 Hz the connections act more like point connections.

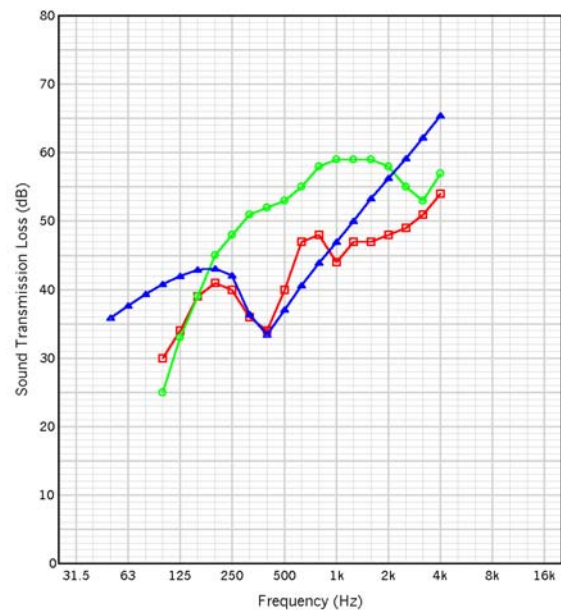
Fig 7 Predicted flanking transmission for 32mm thick timber floor

- measured transmission with flanking
- Transmission loss of wall
- ▲— predicted flanking transmission

This relationship shows the principle factors that influence flanking transmission. Firstly, the sound transmission loss R_c is the transmission loss of the common lining, which is usually plasterboard or a flooring membrane such as plywood or particle board. This element is typically R_w 30 - 35 dB. The radiation efficiency factor can add about 5 dB, the joint loss of typical + joints is about +10 dB and the area factor contributes about +5 dB. Thus typically the flanking path will be about R_w 50 - 55 dB, which will limit the performance obtainable from high performance partitions. However in some situations it can be significantly worse. A particularly severe example of flanking limiting performance was found in a heritage wooden building with 35 mm thick hardwood floors on top of which apartments were built, with the floor running underneath the inter tenancy partition. The timber floor had a rather low critical frequency because of the high stiffness and light weight of the timber floor. The result was that the radiation efficiency was close to 1 over much of the range, with a coincidence dip at a low frequency. The predicted and measured flanking transmission is shown in Figure 7.

The flanking path was predicted to be R_w 44 dB and measured as R_w 42 dB, whereas the inter tenancy partition was designed to achieve R_w 58 dB. In this situation the direction in which the joists ran is significant
